# Manhole Inspection Summary

Manhole # S03WW1012MH

Insp Date: **10/20/06 10:17 AM**

**Location** Address: **3506 GLEN AVE**

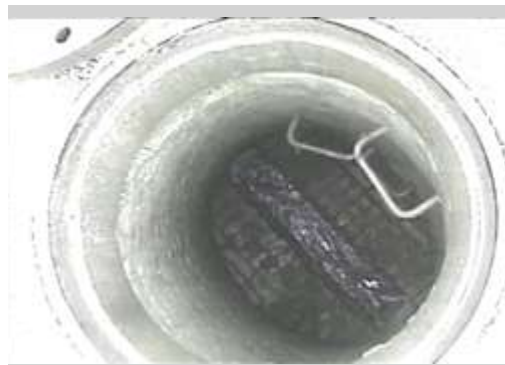
Top View

Frame leaks. Adjustment deterioration and infiltration. Corbel and Barrel infiltration. Evidence of surcharge - Bench

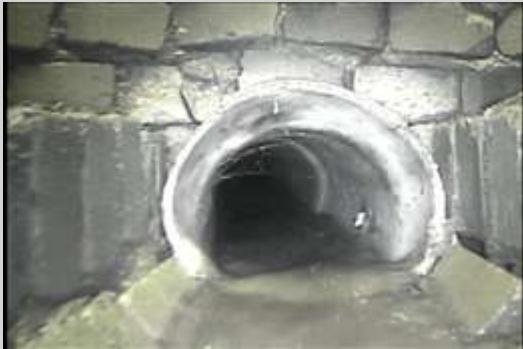
### 8 in. Circular Gravity Sewer Pipe Out @ 12 O'Clock

Barrel deterioration and infiltration. Channel deterioration.

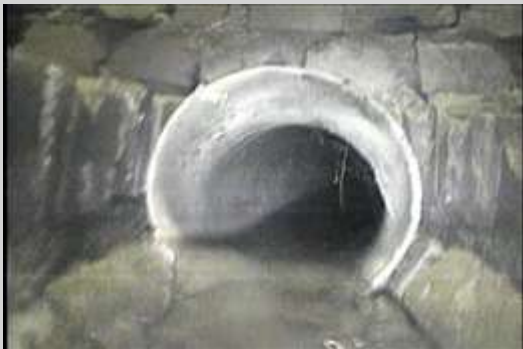
### 8 in. Circular Gravity Sewer Pipe In @ 6 O'Clock

Barrel deterioration and infiltration. Channel deterioration.
